**Sale Name:** October 17, 2025 - Automotive Timed & Live Vehicles & RV's - New Brunswick

**LOT 8 - 2012 Honda Odyssey**

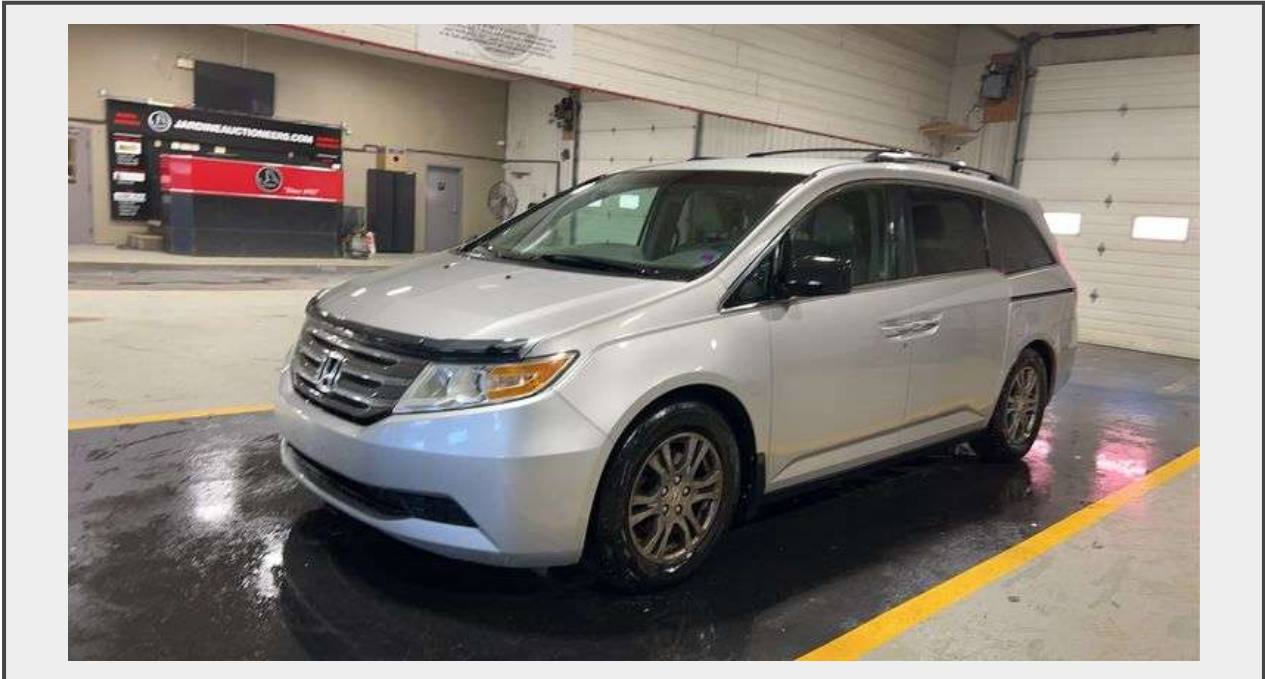
**Comments** Warning Lights: TPMS (Tire Pressure Monitoring System) ON.

**Interior Comments (Jardine)** Headliner/seats/floor stains

**Exterior Comments (Jardine)** Multiple scratches/paint chips, front left door rust specs/inner door rust, rear left fender dents/rust, trunk dents/rust, right rear fender

rust, right rear door paint bubbling/rust, front right door mirror cap broken/taped, windshield chips.
