**Sale Name:** October 21, 2025 - Automotive Timed Vehicles & RV's - New Brunswick  
**LOT 35 - 2011 Chevrolet Silverado 1500 4x2 Work Truck 4dr Extended Cab 8 ft. LB**

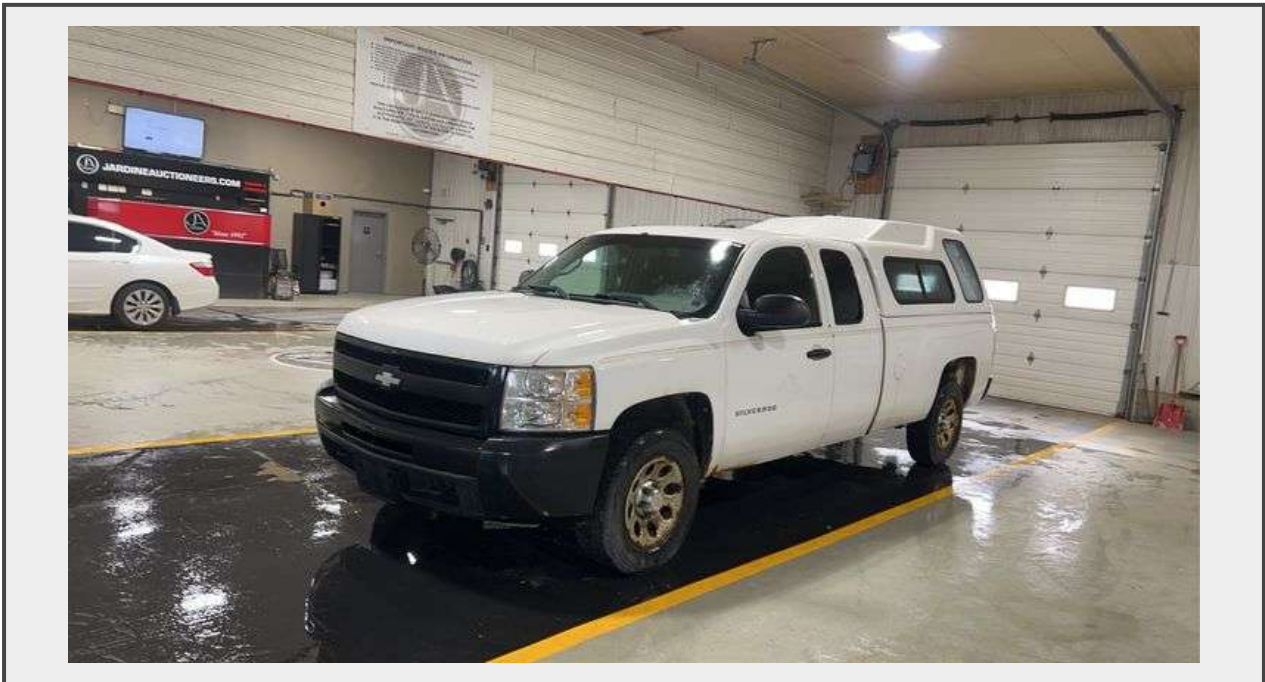
**Declaration** Vehicle Loud - Possible Exhaust Leak

**Interior Comments (Jardine)** Headliner/seats/floor stains, seats tears. \*AC not functioning.

**Exterior Comments (Jardine)** Multiple scratches/paint chips, front left fender rust, front left door dents/rust/inner door/doorsill rust, rear left fender repainted, rear

bumper dents, tailgate dents/rust, right rear fender dents, right rear door dents, front right door dents/rust/inner door/doorsill rust, front right fender dents/rust, hood dents/rust, windshield crack chips.
