**Sale Name:** October 21, 2025 - Automotive Timed Vehicles & RV's - New Brunswick  
**LOT 74 - 2010 Nissan Titan**

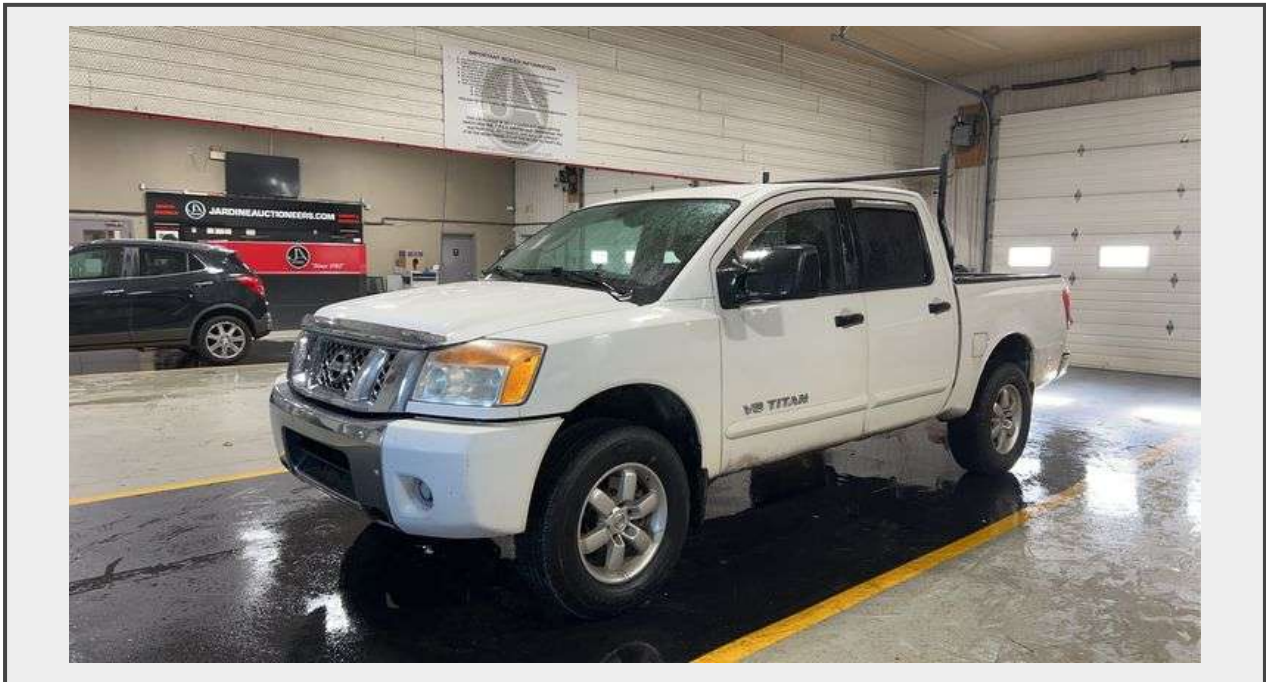
**Exterior Comments (Jardine)** Multiple scratches/paint chips, majority of vehicle repainted, front left inner door rust, rear left fender dents, right rear door dents, windshield chips.
